The Migratory Cortical Button: A Rare Case of Hypersensitivity to Titanium after an Anterior Cruciate Ligament Reconstruction

Nicolas Bouguennec, MD, Philippe Colombet, MD, Nicolas Graveleau, MD, and Stephane Jambou, MD
Sports Clinic of Bordeaux-Merignac, Merignac, France

Keywords: Knee, Anterior cruciate ligament reconstruction, Titanium, Hypersensitivity

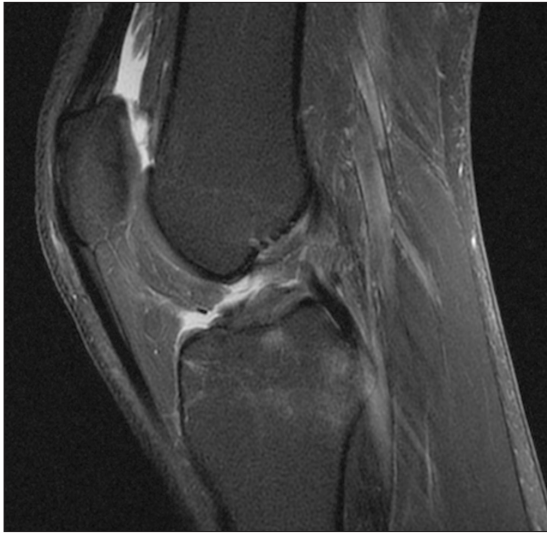
Fig. 1. Preoperative T2 sagittal magnetic resonance imaging of the left knee showing the rupture of the anterior cruciate ligament.

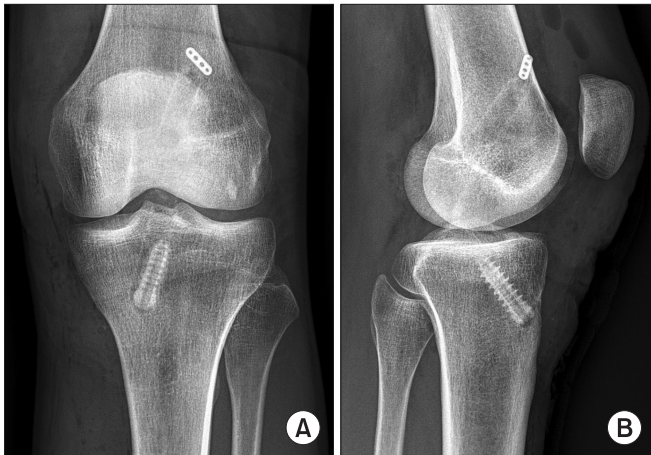
Fig. 2. Postoperative anteroposterior (A) and lateral (B) X-rays.

by a senior surgeon (S.J.) using a RIGIDLOOP™ 30-mm Fixed Loop Implant (DePuy Synthes Mitek, Raynham, MA, USA) cortical button on the femoral side (inside-out technique through the anteromedial portal) and a bioabsorbable LIGAFIX® screw 9/30 (S.B.M., Lourdes, France) on the tibial side (Fig. 2). The surgery was uneventful and initial postoperative outcomes were satisfactory. Rehabilitation was started the day after surgery for ambulation recovery under full weight bearing with a brace and crutches used for one month.

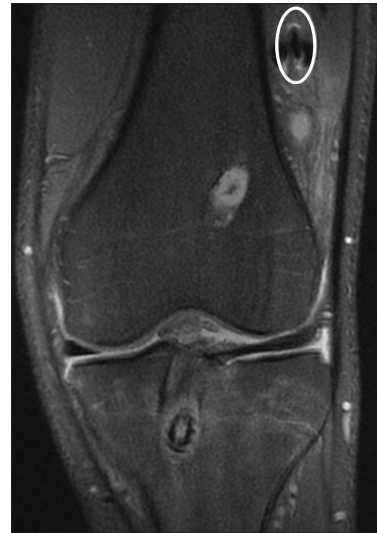
Fig. 4. Postoperative 9-month frontal T2 magnetic resonance imaging. The femoral cortical button (circle) is no longer located on the lateral femoral cortex but migrated in the soft tissues of the thigh.

curettage of the tibial tunnel. Intraoperative samples showed no sign of infection. On the 9-month postoperative MRI, the femoral cortical button was observed to be no longer fixed against the femoral cortex (Fig. 4); however, since no symptom was reported on the femoral side by the patient, no additional procedure was done. Clinical results were satisfactory, and the patient returned to his daily and sports activities without symptoms 3 months after the screw removal with curettage.

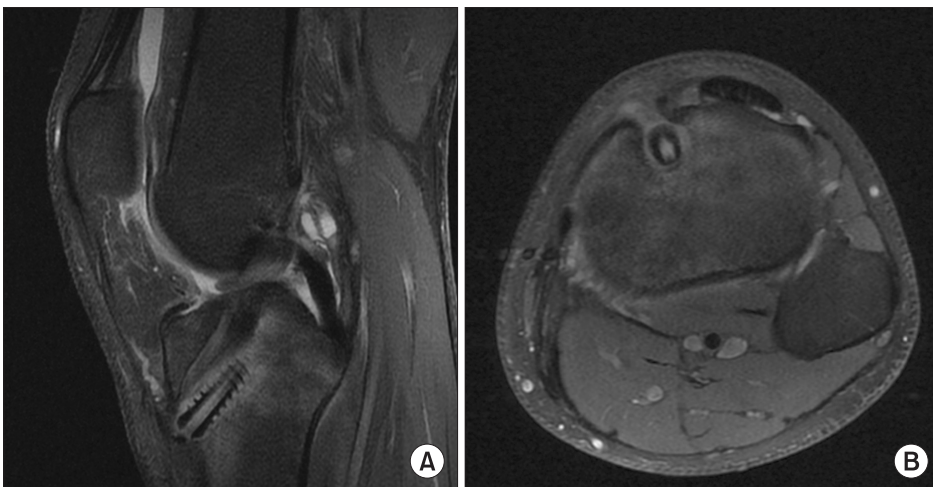
Fig. 3. Postoperative 9-month T2 sagittal (A) and axial (B) magnetic resonance imaging showing an increased signal intensity around the bioabsorbable screw beyond the tibial cortex indicating a tibial cyst.

Nine months after the surgery, the patient came to the clinic because of pain at the aperture of the tibial tunnel. A cyst around the tibial screw was observed (Fig. 3). As he complained of pain in the course of daily activities, the screw was removed with

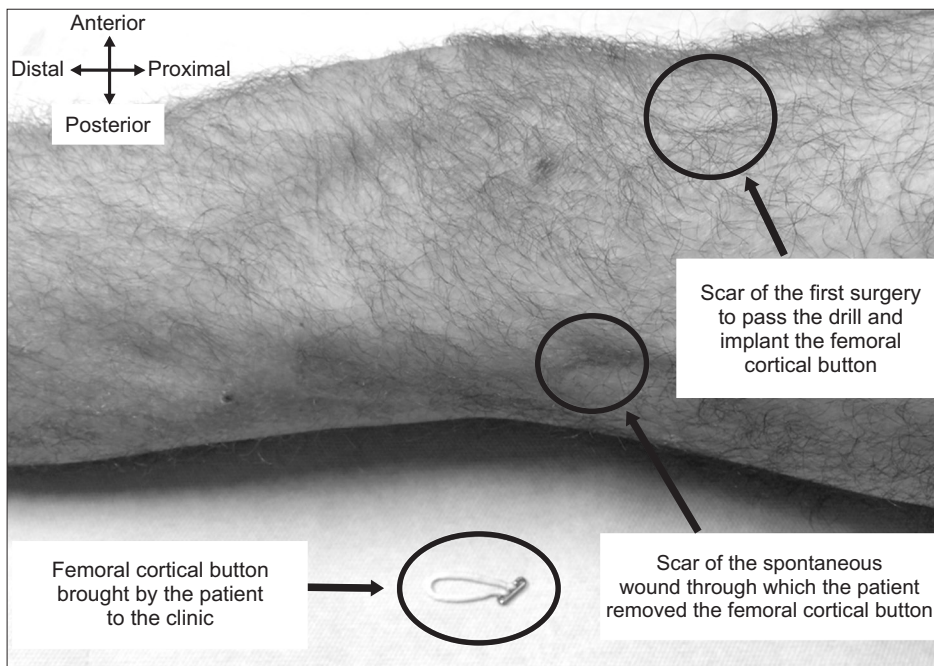
Fig. 5. Photograph of the lateral side of the left knee. The patient removed the cortical button by himself though the spontaneous wound located posterior to the scar made for drill passage in anterior cruciate ligament reconstruction.

Three years after the surgery, the patient called the clinic because the cortical button had protruded from the skin: the skin had spontaneously opened 3 days before his call and he just pulled out the device which was deep in the wound. He was seen at the clinic the following day with the femoral cortical button in his hand; he had removed it from his thigh. The wound was located posterior to the scar left by the drill used to implant the cortical button device during the initial ACL surgery (Fig. 5). No antibiotics were prescribed to not hide an infection. The scar healed in one week with dressings and the clinical condition was good without any sign of infection. The patient was seen 6 months after the removal of the cortical button. Clinically, the Lachman test result was negative and the pivot shift test results was negative with a full range of motion. After the wound healed, the patient resumed the practice of judo without any instability. The MRI done three and a half years after the ACL reconstruction showed normal signal and orientation of the ACL graft (Fig. 6). No abnormality was found at the distal femur and soft tissues of the thigh (Fig. 6). As all allergy tests had already been done for

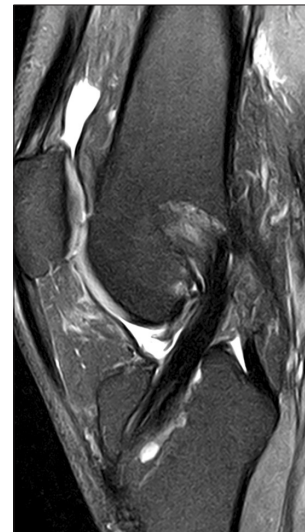
Fig. 6. T2 sagittal magnetic resonance imaging at more than 3 years of follow-up after removal of the femoral cortical button. The signal of the anterior cruciate ligament is normal.
